## Construction Progress Update through 1/28/2015

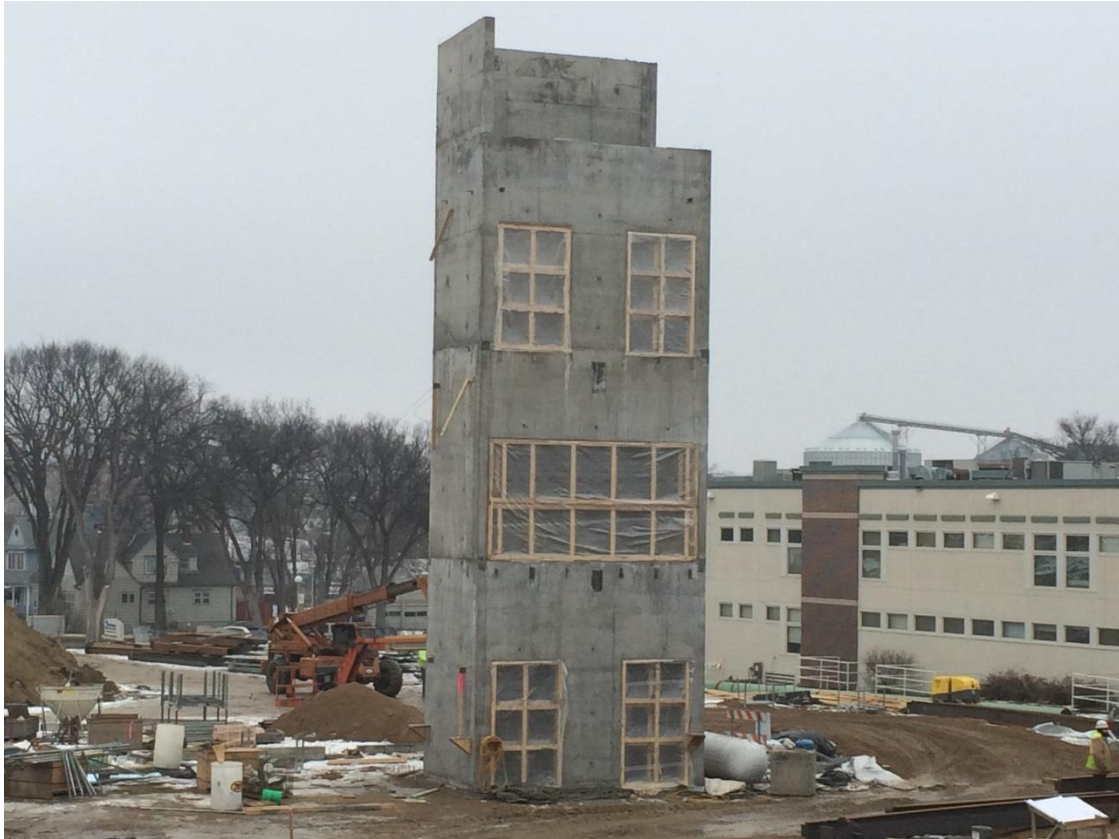
Elevator core walls complete.

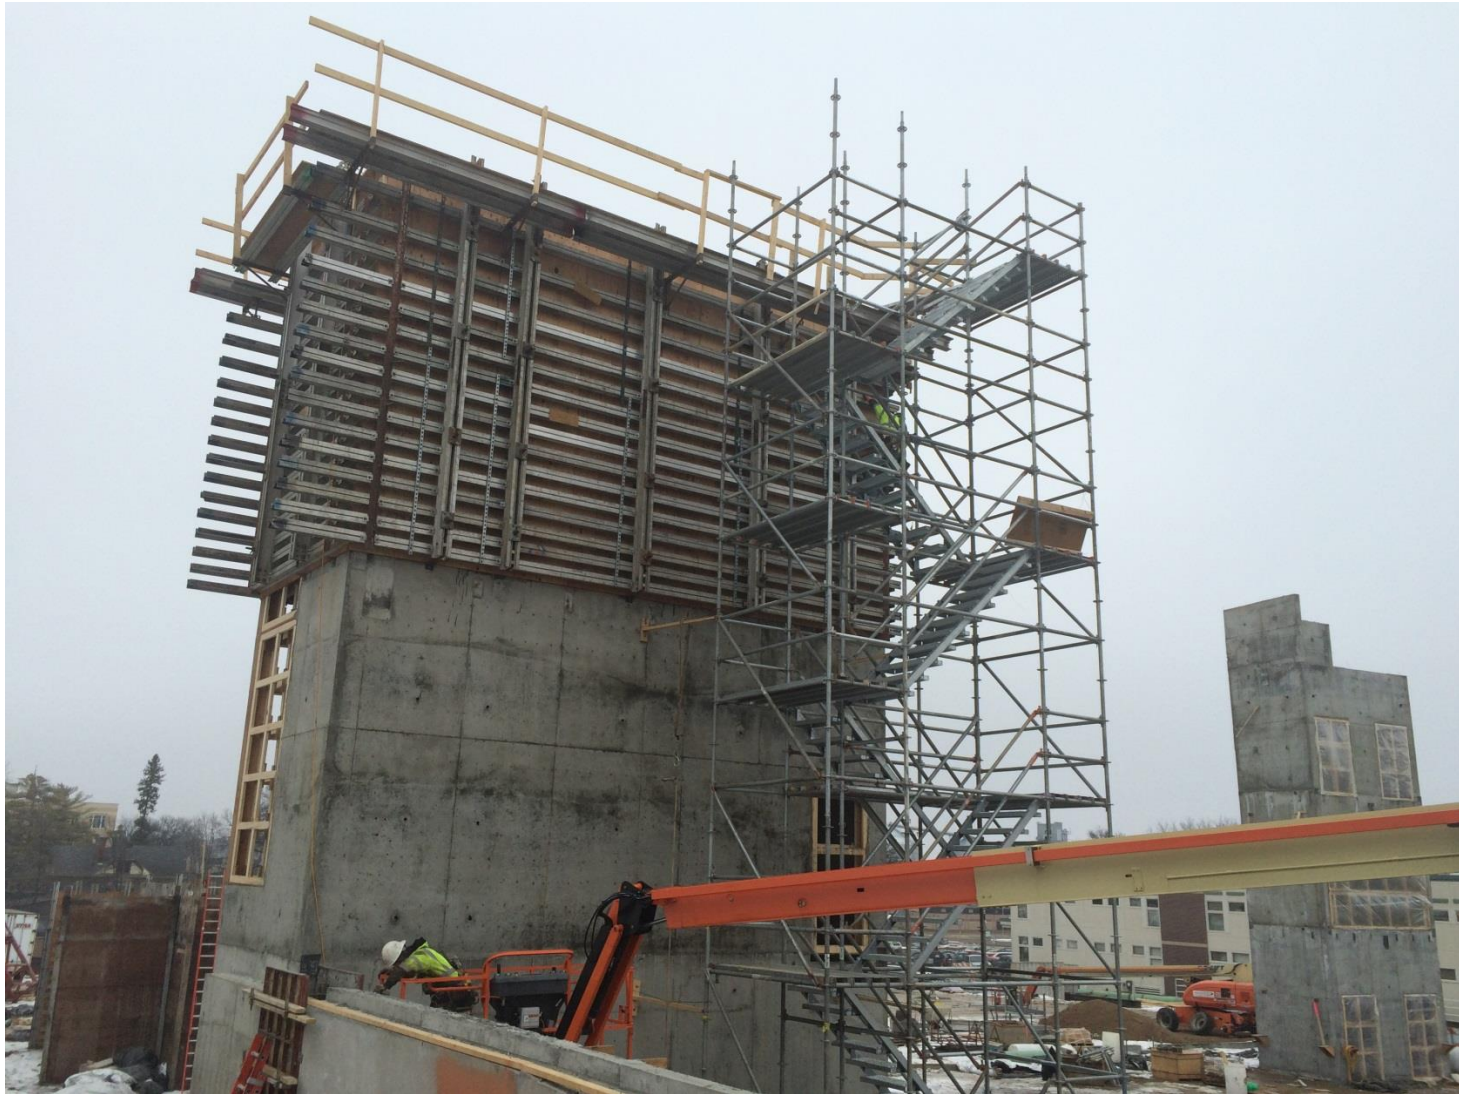
Third and final level of Stair A being formed.

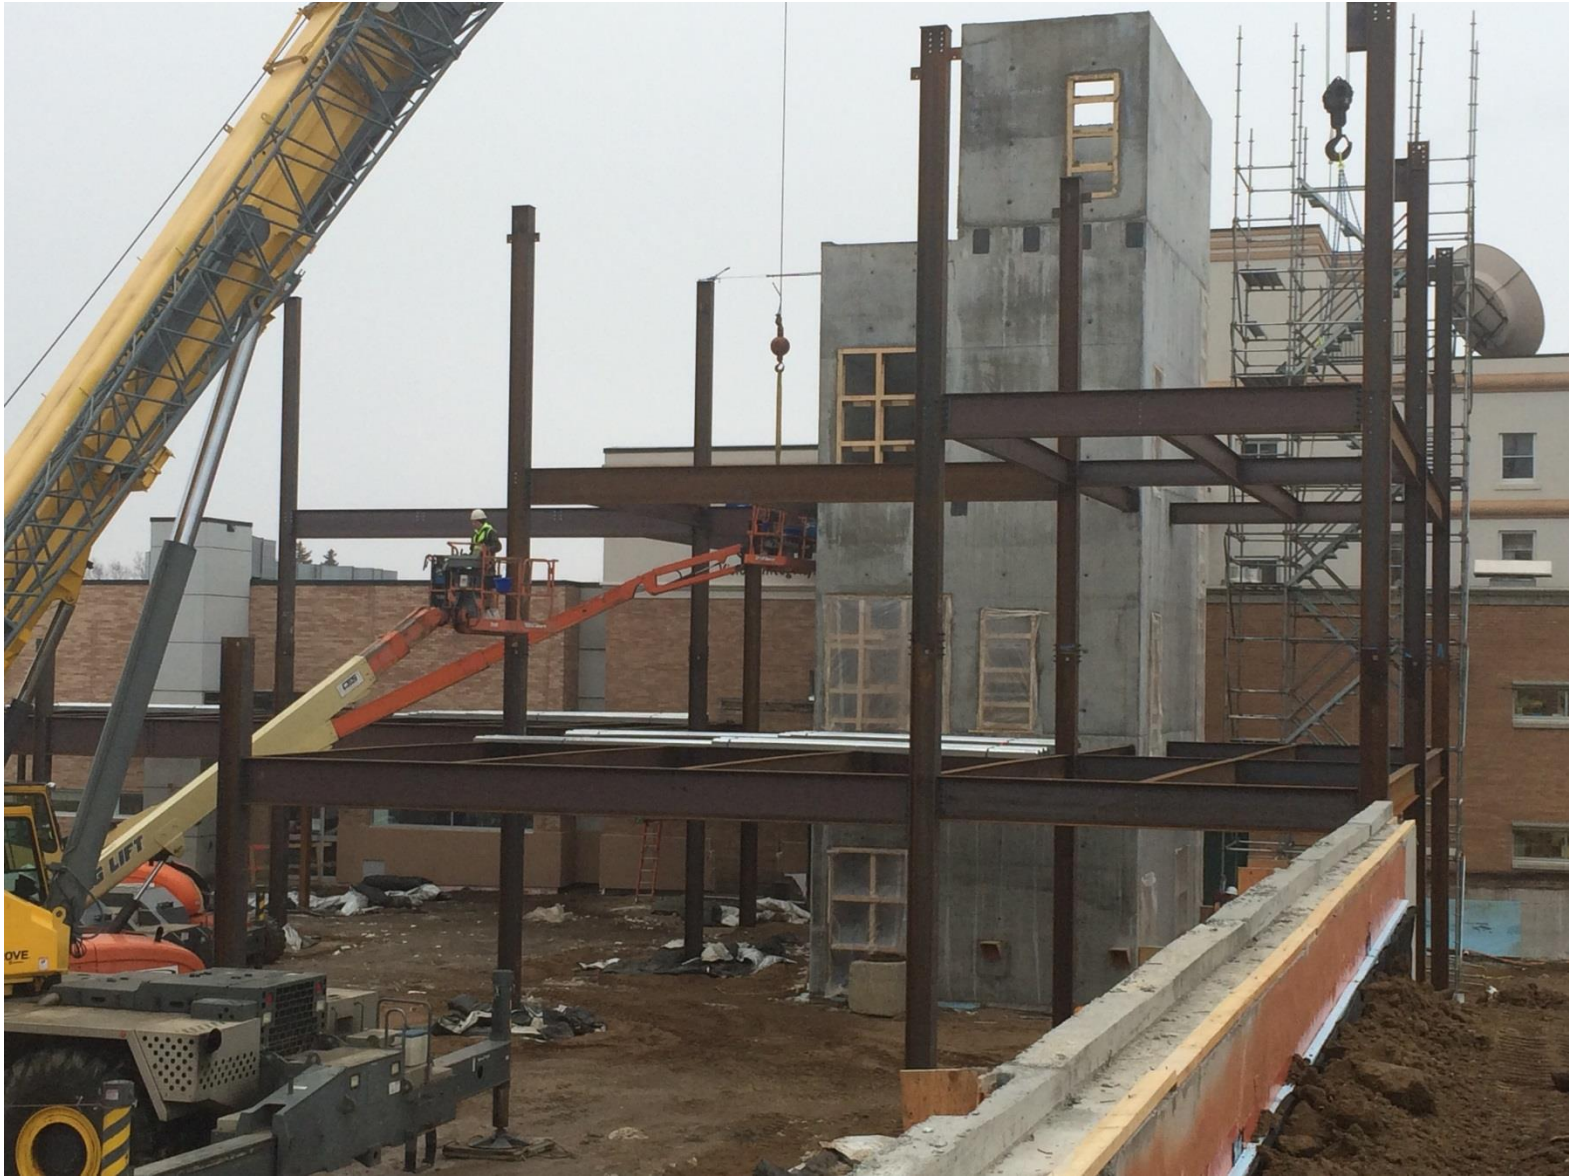
Steel Erection has begun.

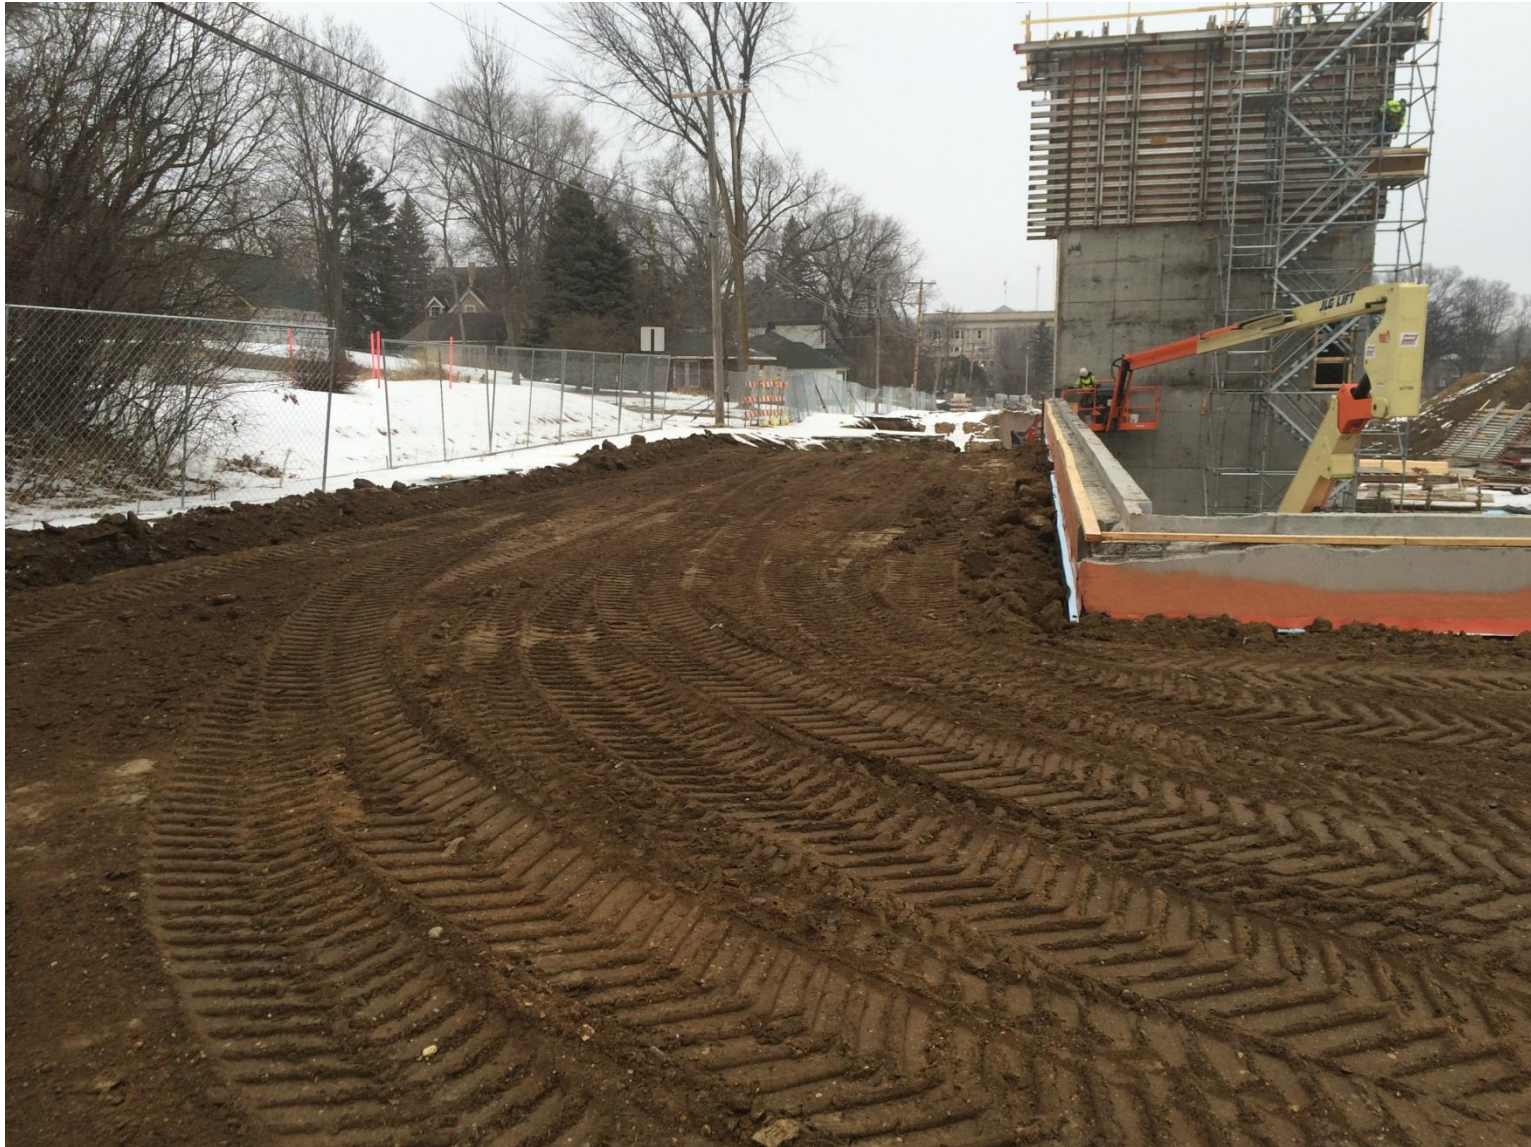
West wall water proofed and backfilled.

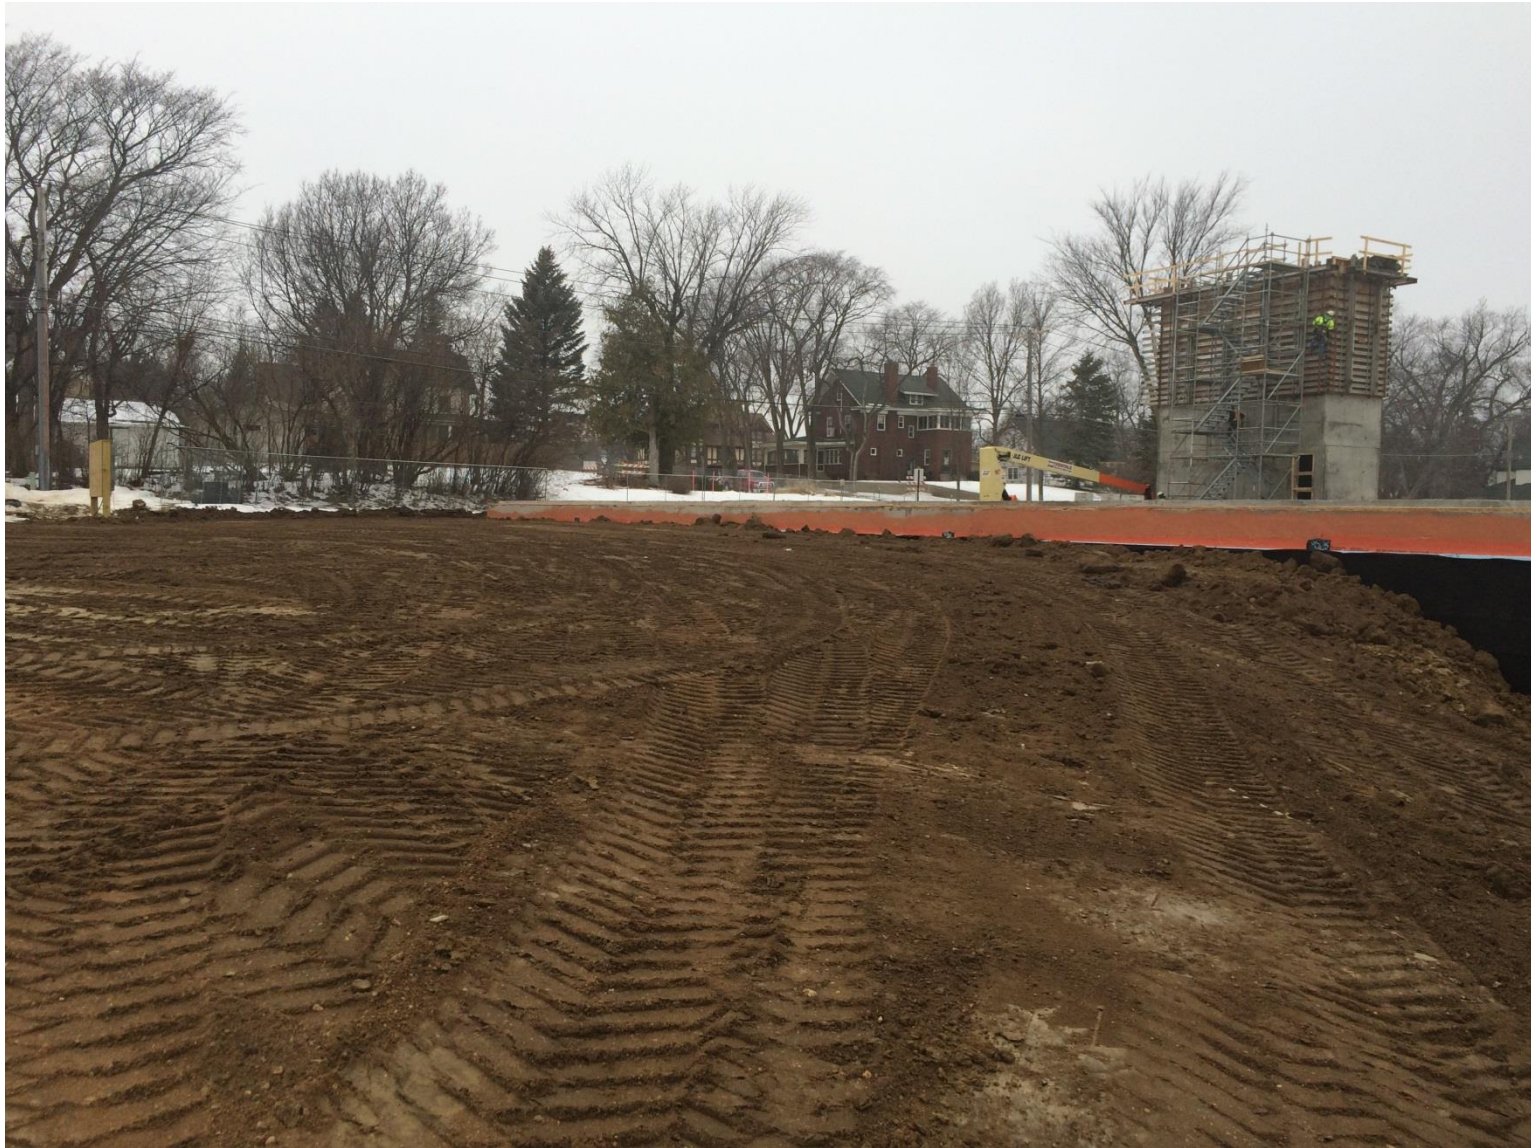
South wall water proofed and back filled.

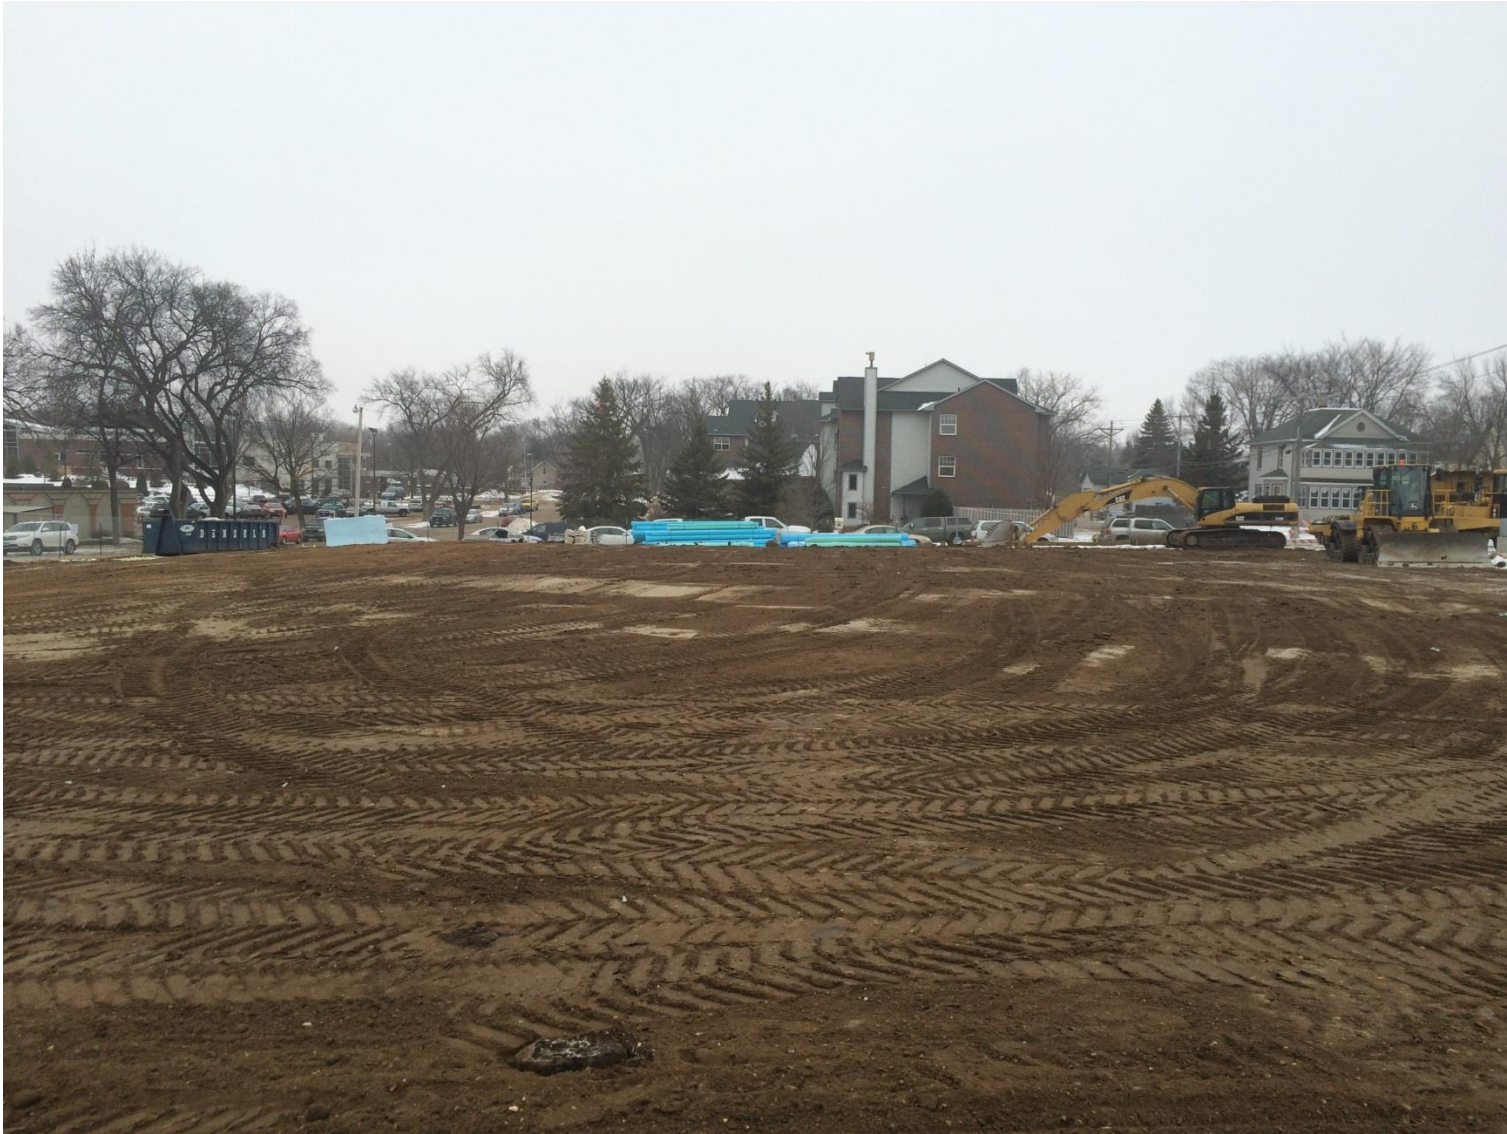
South dirt stockpile removed.
